### East Elevation Notes:

**Phase 01 - Approach to Repairs (Issued for Committee Comment). East Elevation.**

**Issue: A (FMR) on 21.07.2021 for Trustees Meeting / Approval.**

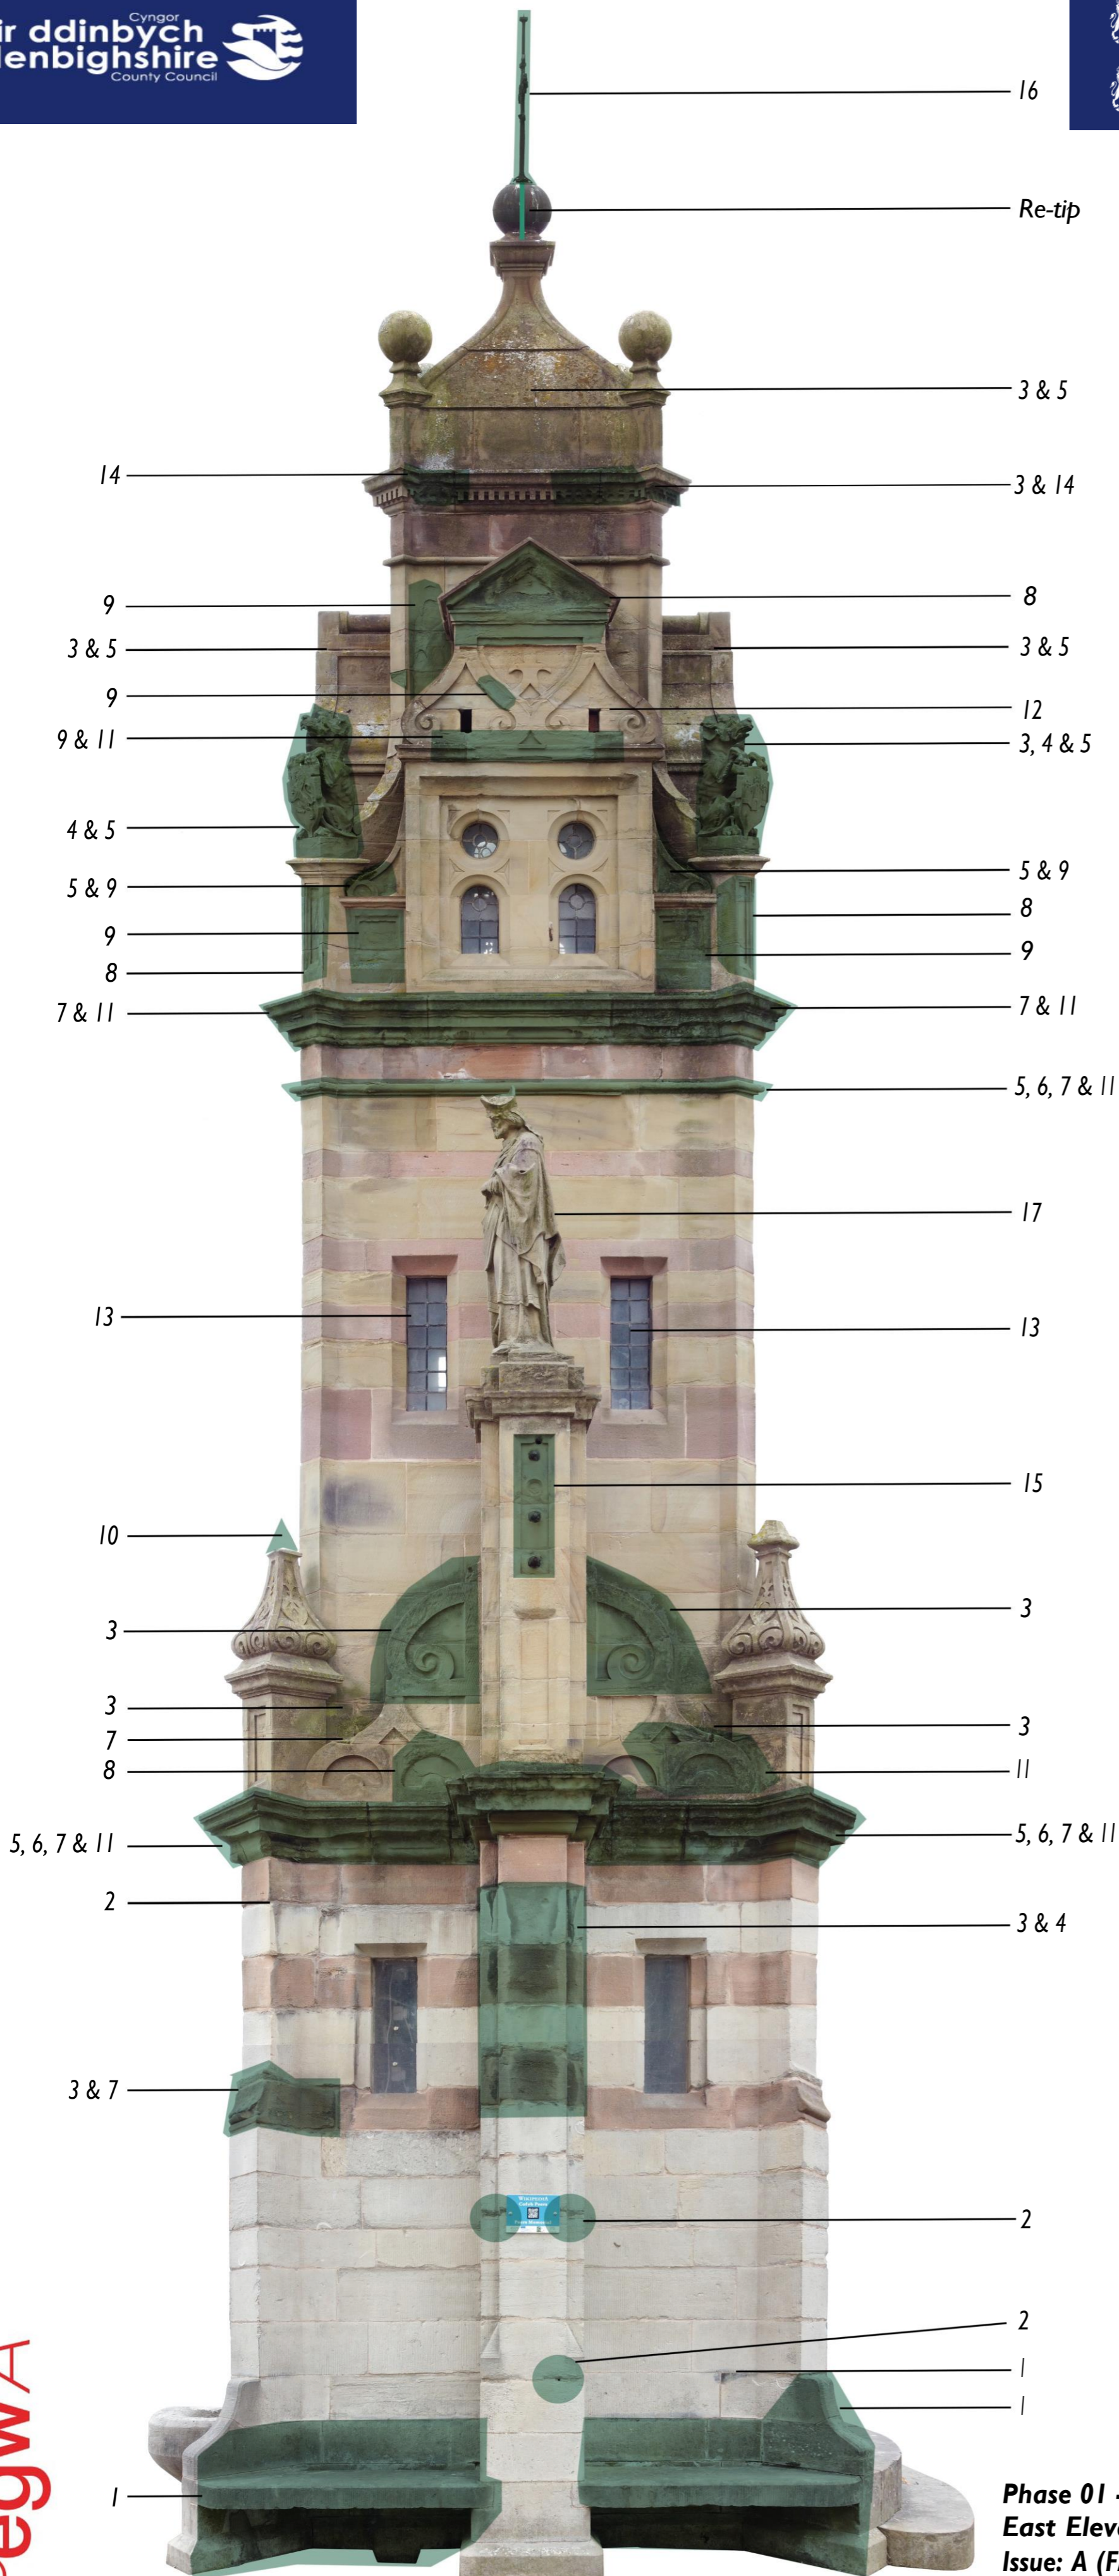
5. Take off all water-retaining furry mosses to top of cill. No need to brush off lichens.
6. Rake out all vegetation from joints and repoint.
7. Carry out plastic mortar repairs to establish run off to ledges. Need for micro-pinning of stonework in areas to East elevations, in areas of corners.

8. Infill cracks with mortar and stone dust, plastic mortar repairs and apply Keim shelter coat to consolidate surface and improve longevity. Some micro-prinning may be required perhaps to any loose surfaces, or indents.

11. Brush down black soot to remove hard crust. Use a hard bristle brush (trial initially). It may be necessary to use a poultice, or laser clean if not.

16. Re-tip the top finial with a s/s rod if required (assume to be ferrous potentially), clean the ironwork and repair any ferrous joints (confirm what metal this is to inform repairs, does not look like wrought iron as the dimensions are too fine – is it copper or even bronze?).

1. Clean stonework to the base of the plinth with a hard bristle brush and water.
2. Repoint missing and loose, and areas of hard cementitious mortar, with a soft lime hot-mixed mortar, with crushed stone dust to match the colour of the light grey stonework always.

3. Clean stonework with a hard bristle brush and water.
4. Apply Keim shelter coat in colour to match existing. Rake out areas of excessive cement pointing.

9. Brush off delaminating stone face and apply Keim shelter coat to match stone colour to the whole pediment to protect & so it reads as one panel.
10. Re-establish top of finial to south-east corner with new stone piece (based on pro file taken from the south-west corner). Fix with s/s rod and resin, and point up with lime mortar mix with stone dust.

12. Infill in holes within stonework to East too, as to West (with S/S mesh) to stop birds ingesting.
13. Review leadwork on scaffold, repairs to be specified after closer inspection. Allow contingency for minor repairs.

14. Repair and replace stone teeth detail where missing and apply Keim shelter coat to match stone colour to the whole area so it reads as one panel.
15. Reinststate gas lamps or plug in holes with stone & remove the ferrous fixings. Allow contingency for lamps to be installed with photovoltaic and electric light. Restored replicas of original metal lamps from photos.
