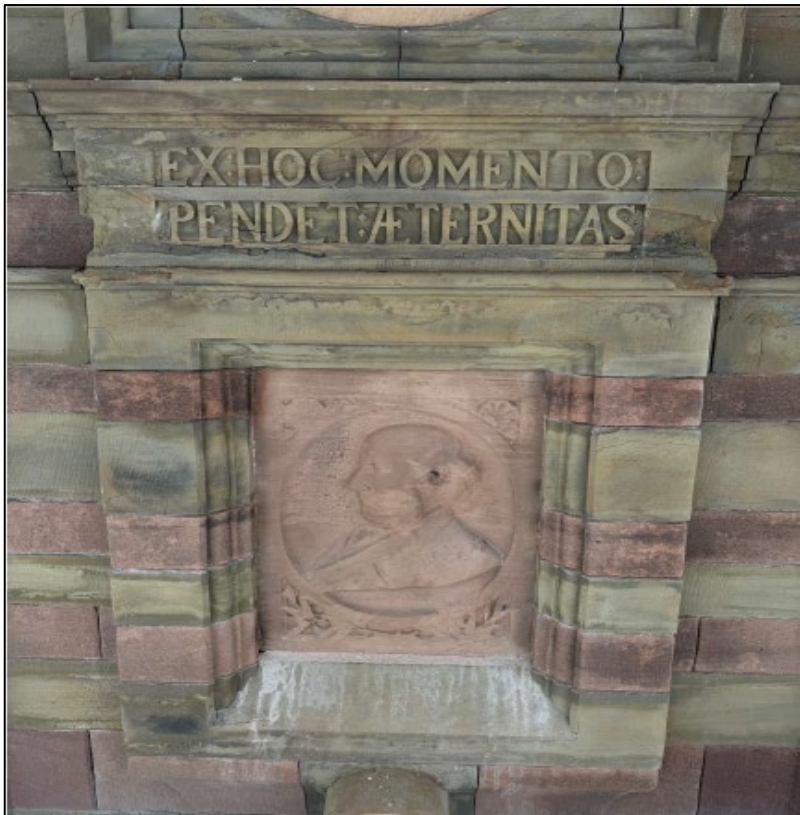
Previous chemical cleaning (acid)

The monument has been cleaned with chemicals / acid in the past, which has stained the stonework.

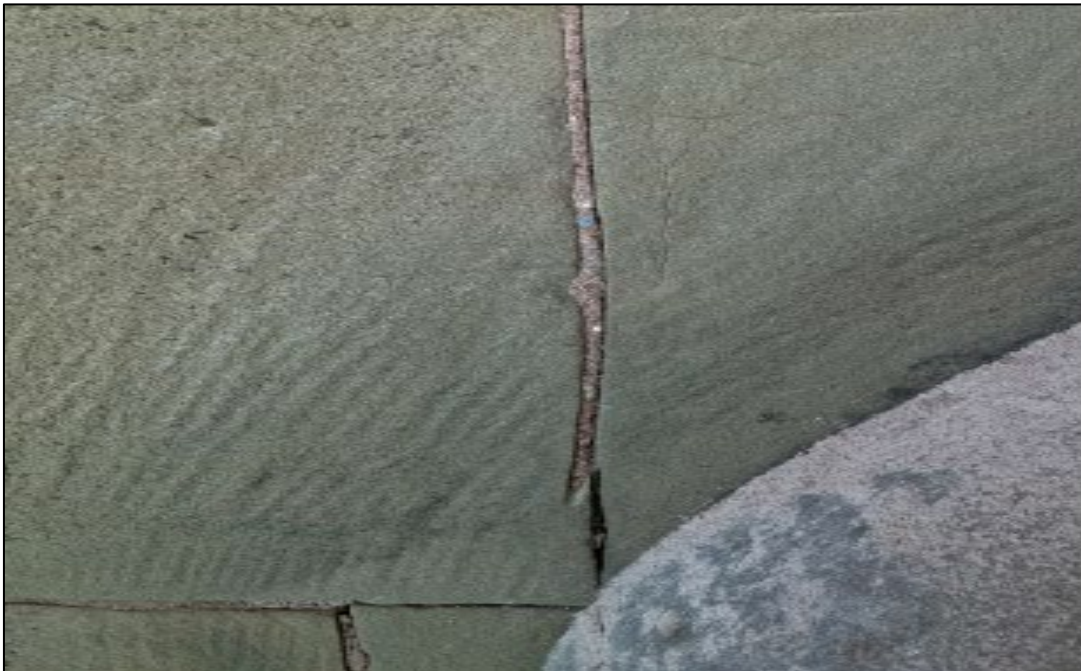
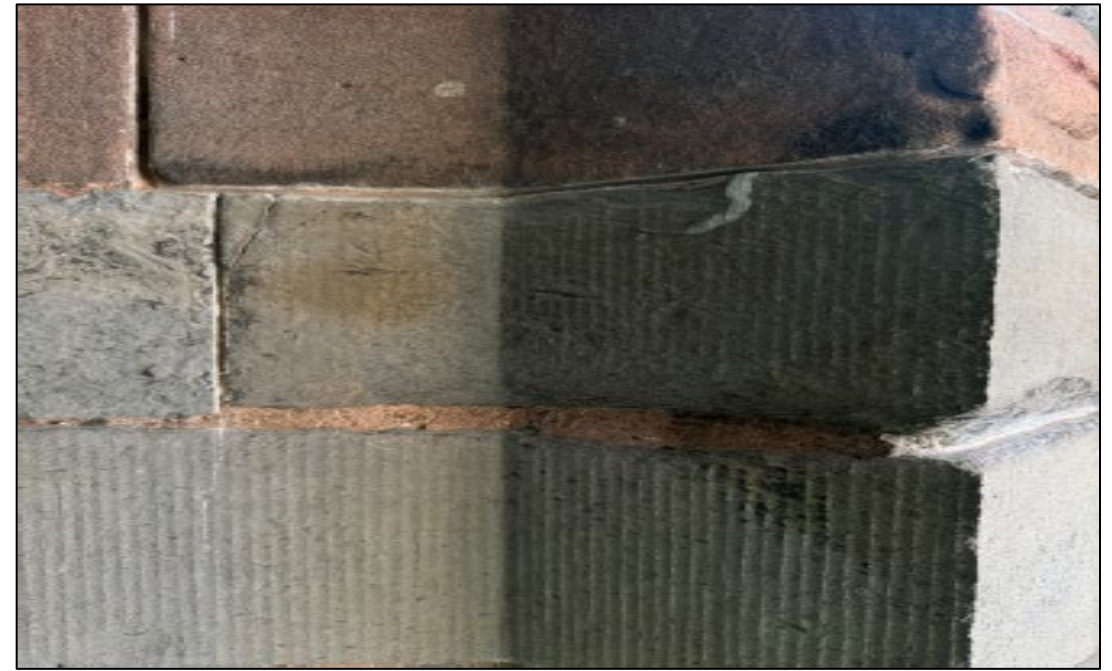
Pointing removal with hand tools

Damage caused to the stone by the use of angle grinders. Incorrect pointing carried out previously in red sand cement mortar.

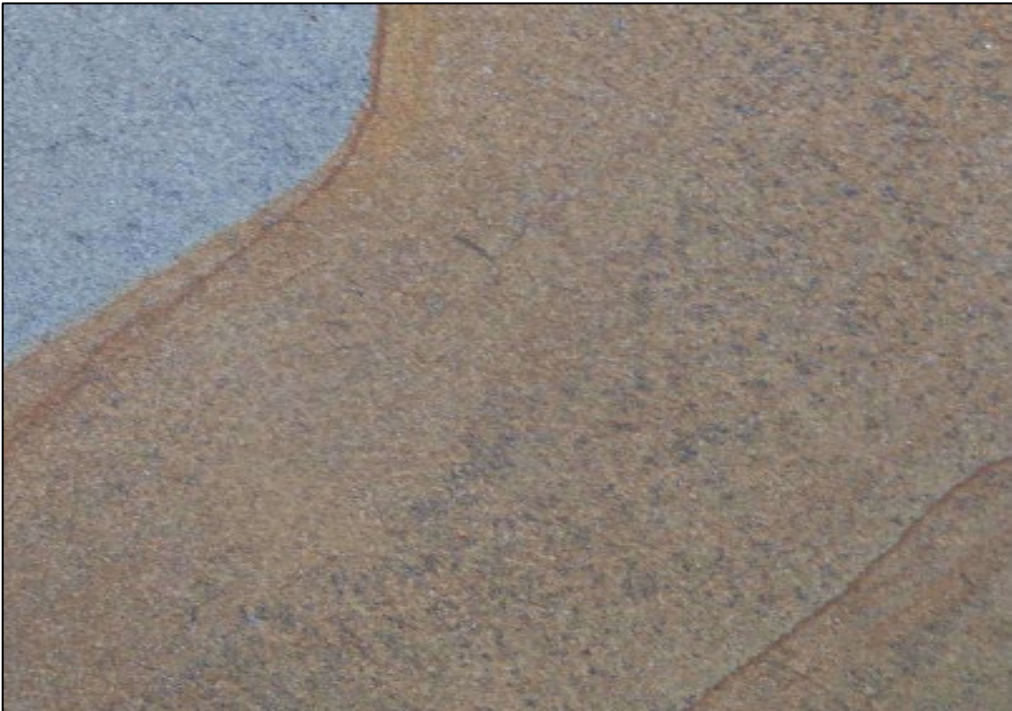
Stone sample analysis

The existing stone was from Gwespyr Quarry, which is now closed.

The closest match is Woodkirk York Stone. The new masonry units are now being manufactured.

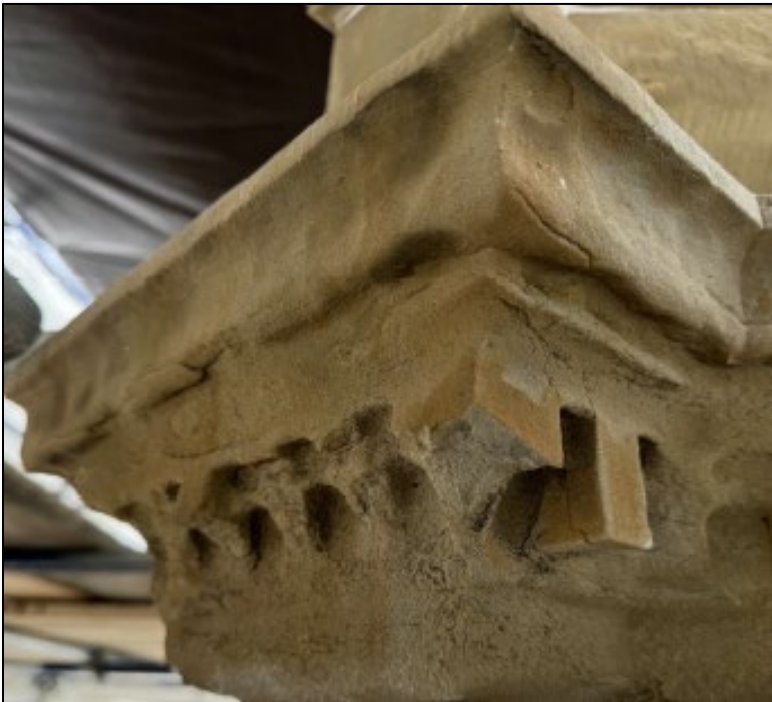
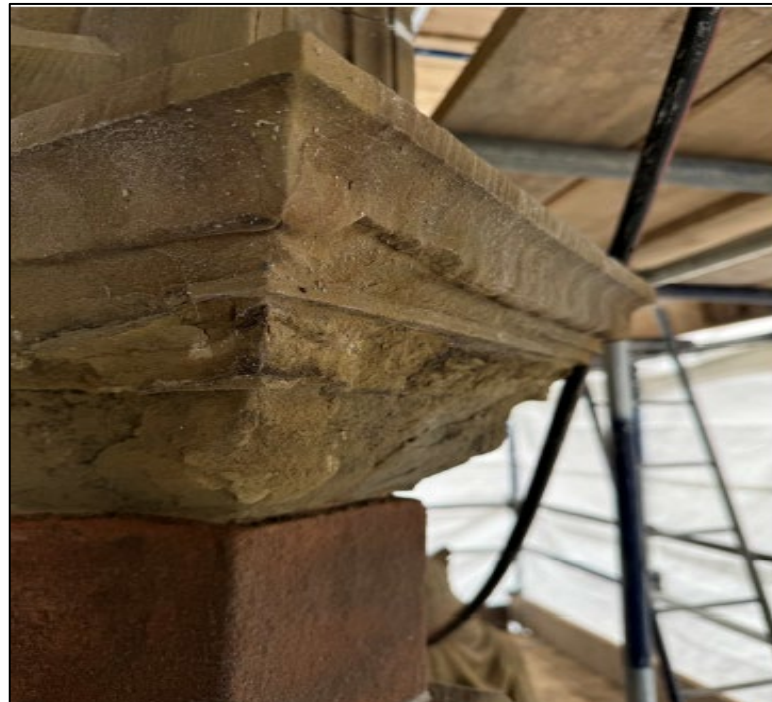
Defective stones to be replaced

The main areas of defective stone are the cornice, string course and dental course.

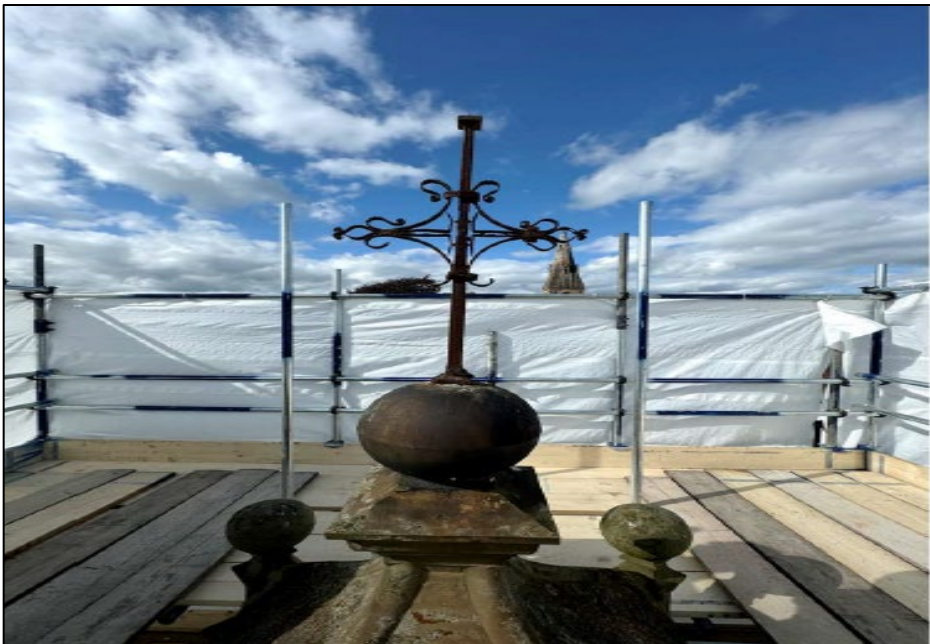
Wrought iron cross and copper ball finial

The existing ball finial is made of copper and the original gold leaf gilding can still be seen. This will be regilded with 24 carat gold leaf.

The existing wrought iron cross will be removed to be restored at the workshop.

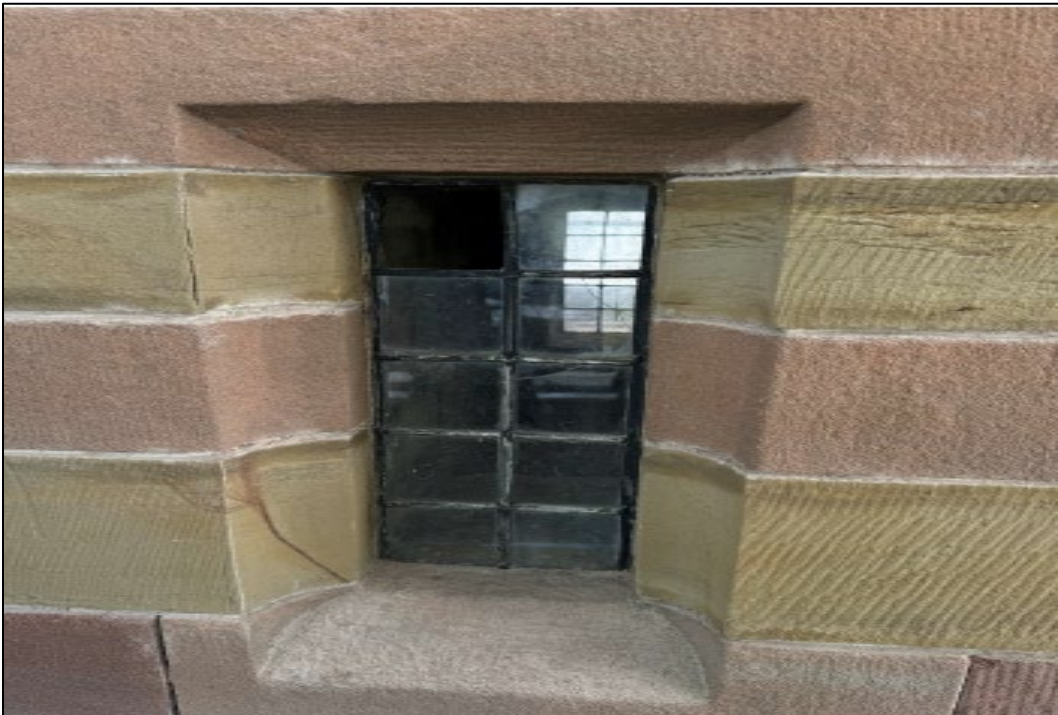
Lead light windows

The existing windows were made from lead light, with Perspex in the bottom windows.

Some of the lead lights at the top are damaged or missing. These will be removed and restored off-site.

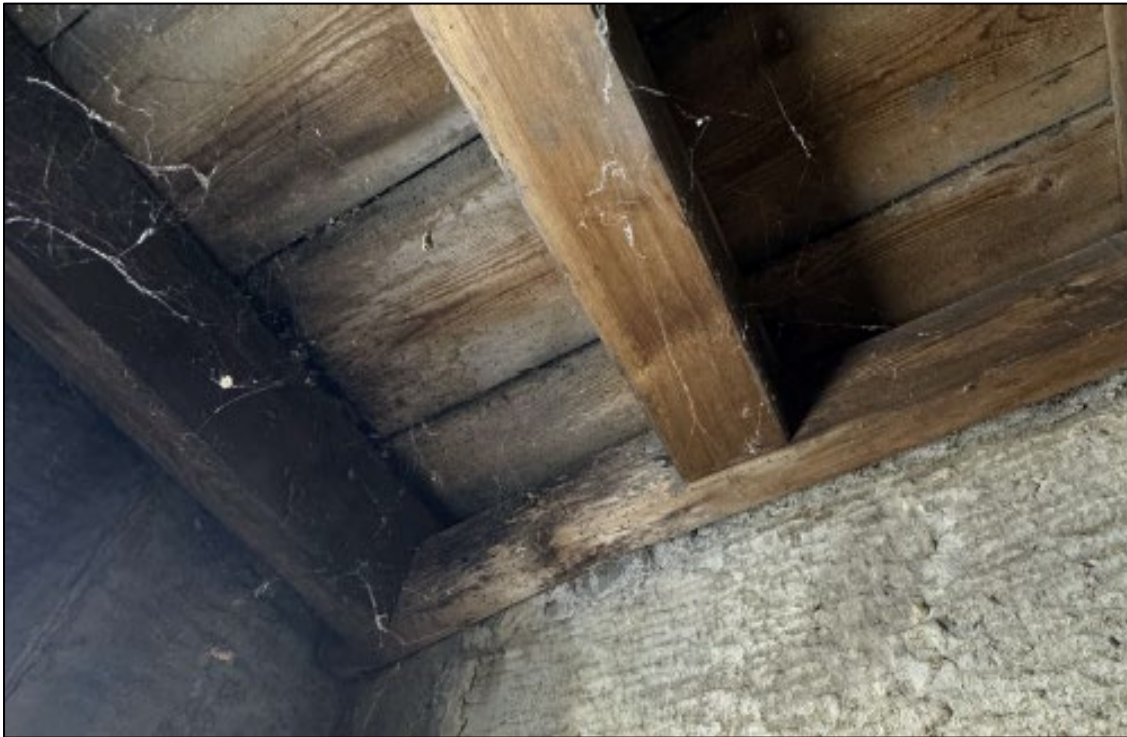
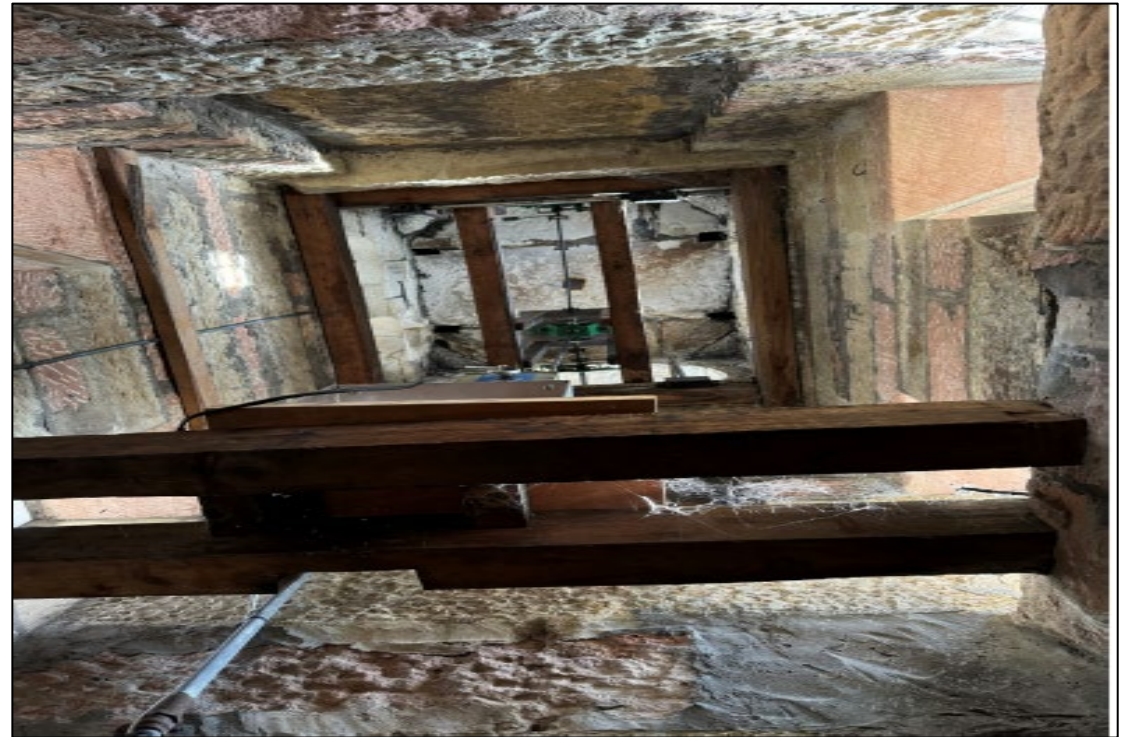
Internal works

Rainwater has got in through the masonry joints. This has caused the joinery and flooring to rot.
